**NORTH DAKOTA
DEPARTMENT OF TRANSPORTATION**

Experimental Study ND 94-07

**Scoping Edge Drains with
an Optical Camera**

Project IM-8-094(005)331

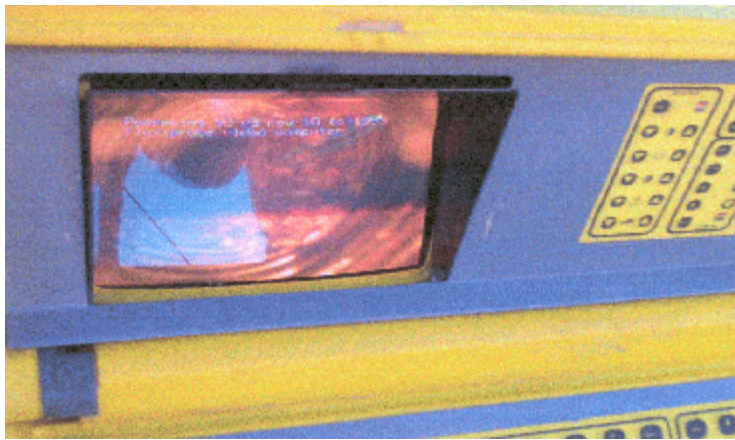
The Pearpoint optical camera system worked very well in observing the internal edge drain system. Performing regular maintenance is all that is needed to ensure optimum performance. Photo 3 shows what is observed on the optical camera monitor. If you look past the reflection on the screen, aggregate can be seen in the drain pipe.

Photo 3: Aggregate blockage in drain pipe.
